Manhole Inspection Summary

Manhole # S03YY1011MH

Location Address: **6006 CLOVER RD** Cross Street: **PARKINGTON AVE**

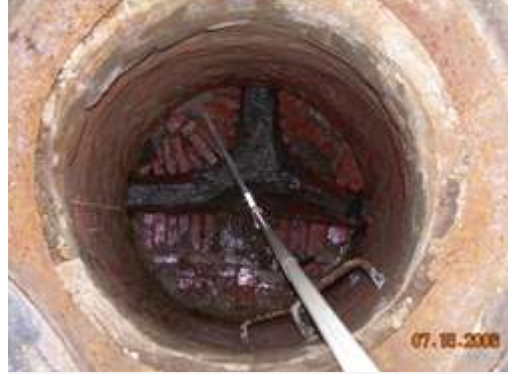
Top View

Evidence of surcharge - Bench debris.
Corroded steps.

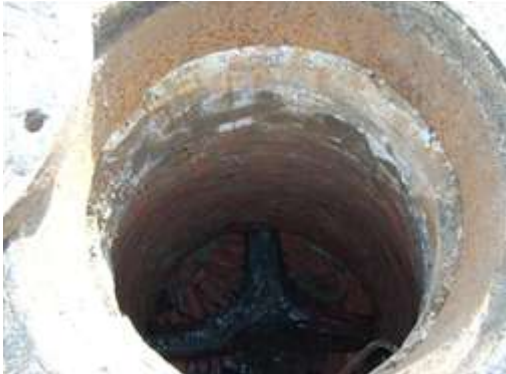
Defect

Adjustment deterioration and infiltration.
Corbel and Barrel infiltration.

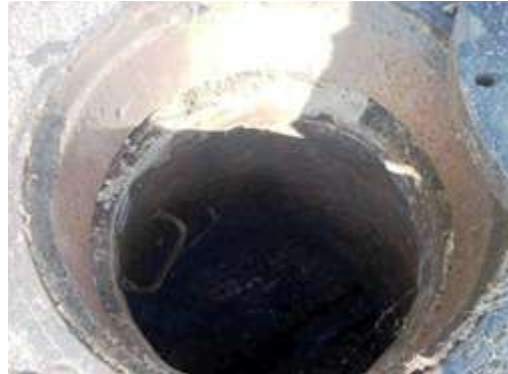
Defect

Adjustment deterioration and infiltration.
Corbel and Barrel infiltration - other side.

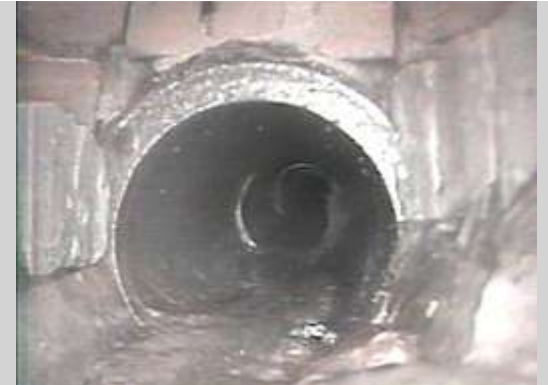
8 in. Circular Gravity Sewer Pipe Out @ 12 O'Clock

Infiltration: **Evidence** Pipe Seal Cond: **Cracked**

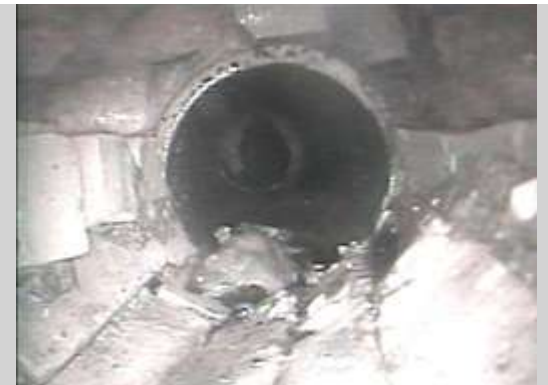
8 in. Circular Gravity Sewer Pipe In @ 3 O'Clock

Barrel deterioration, root intrusion and infiltration. Bench and Channel deterioration.

Infiltration: **Evidence** Pipe Seal Cond: **Unknown**

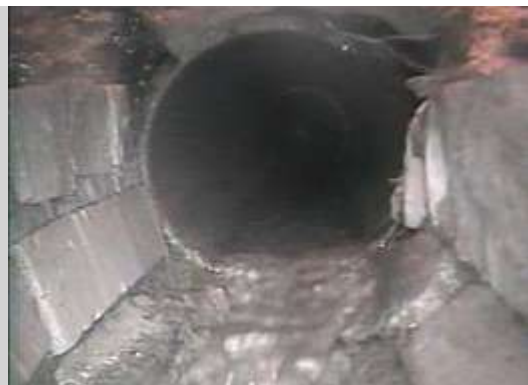
Pipe In @ 9 O'Clock

Channel deterioration.

Infiltration: **Evidence**

Pipe Seal Cond: **Roots**
